ENVOY restored

Voyage of the
ENVOY *Part four*

PARTS ONE, TWO AND THREE OF THIS SERIES DETAILED THE PURCHASE OF OUR NORDHAVN 46 PASSAGEMAKER, ENVOY, AND OUR CRUISE FROM OSTIA IN ITALY TO MARMARIS IN TURKEY, WHERE WE LEFT ENVOY ON THE HARDSTAND IN JANUARY 2008, NOT KNOWING WHEN WE WOULD JOIN HER AGAIN. PART FOUR IS LARGELY TECHNICAL, DEALING WITH THE ISSUES WE FACED AFTER WE RETURNED TO ENVOY IN APRIL 2010 TO RESUME OUR CRUISING.

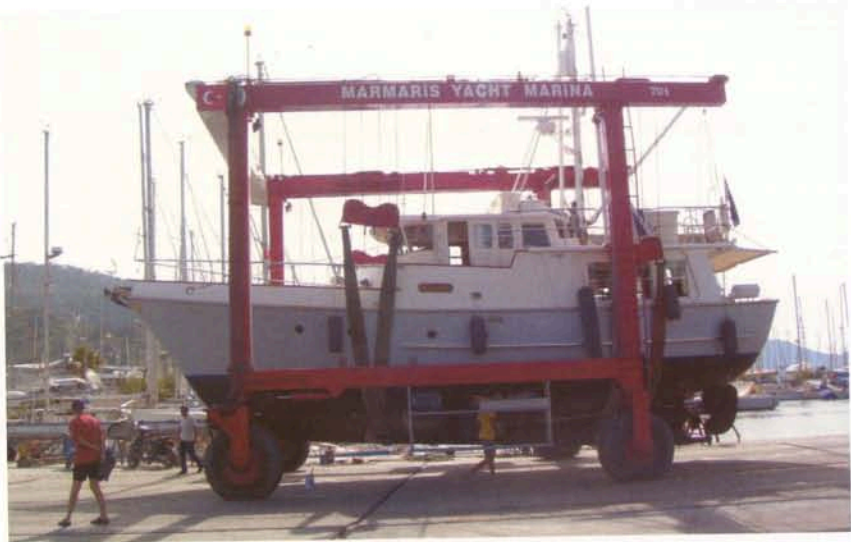
ENVOY IN THE TRAVEL LIFT SLINGS DURING RE-LAUNCHING AT MARMARIS

Although there was still much work to be completed, Envoy was launched on 12 May after 28 months out of the water. Apart from being more comfortable for us living aboard Envoy in the water, this was important because all sea cocks had been removed, serviced and re-sealed in place, and we needed to ensure there were no leaks. Better that we find any leaks then, with time on our hands. In fact there were only a couple of minor water leaks from hoses, solved by tightening the hose clamps.

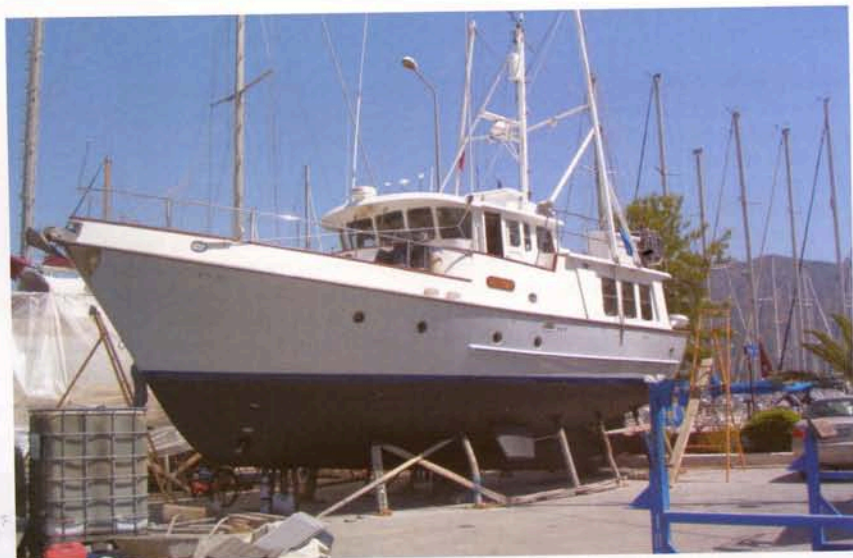
ENVOY ON THE HARD AT MARMARIS PRIOR TO RE-LAUNCHING

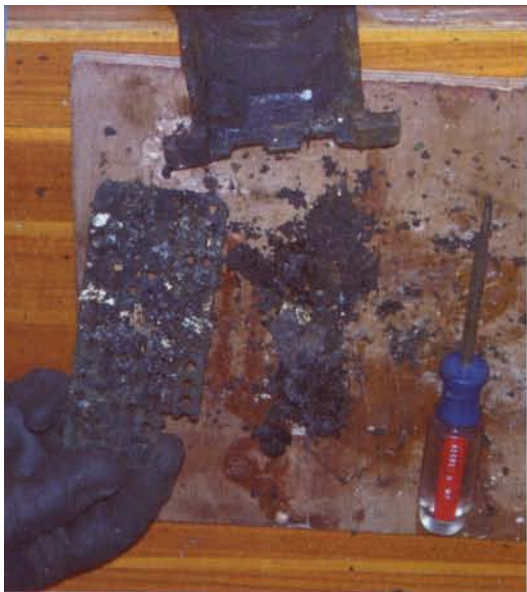
IT'S IMPORTANT TO REGULARLY CHECK YOUR BILGE PUMP STRAINERS AND CLEAR THE DEBRIS WHICH ACCUMULATES AS SHOWN IN THIS PICTURE OF ENVOY'S STRAINER.

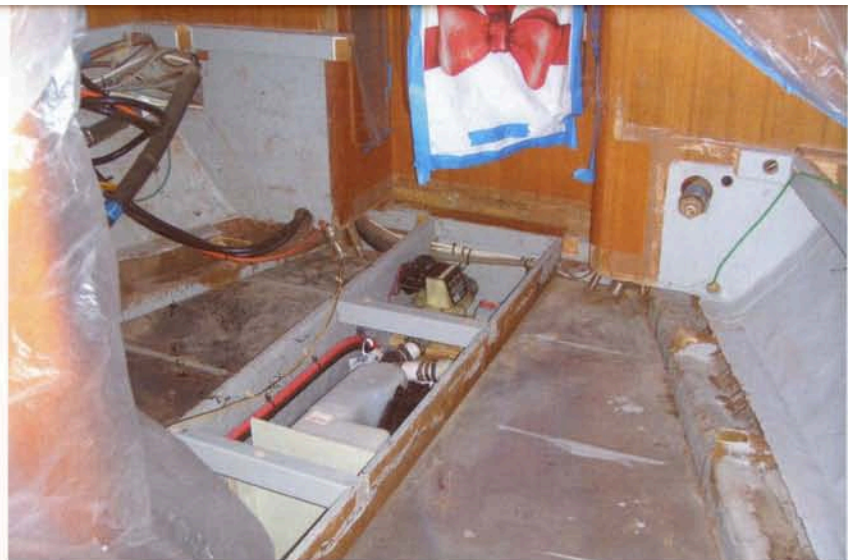
bilge was dry, but now it contained about 50mm of water. I dried out the bilge, but there was still fresh water coming into the bilge from forward. The source turned out to be leakage from two out of our three 20 year-old stainless steel water tanks. The water was finding its way from the bilge to the bottom of the keel where a section of the bilge's gelcoat under the propeller shaft had deteriorated, with large cracks through the gelcoat going down into the laminate. This was a very difficult area to access, but fortunately the new propeller shaft had not yet been installed through the bilge, so we had a bit of room, and Demir removed the old gelcoat using long chisels. Then we dried the bilge using a hot air gun for a couple of days before Demir laid some new glass cloth and gelcoat making the bilge totally water tight. A couple of days after that was completed the drip from the bottom of the keel stopped and Demir were able to finish coating the small area under the keel they had left to drip.

to find the leaks, fix the leaks and re-install them – simple enough? No, wrong! Aboard Envoy these tanks are under the cabin sole in the guest cabin. One is under the built-in double berth, and has the air conditioning compressor mounted over the top of it. The other is partly under a built-in settee. We met with Demir on board, and concluded we had to dismantle the guest cabin bit-by-bit until we could get the two tanks out. As these were the original 20 year-old stainless steel tanks Demir suggested that we fit new tanks to reduce the risk of going through this process again. We had to remove everything stored in the guest cabin and it took a Demir carpenter four days to dismantle the guest double berth and settee, and pull up the cabin sole of teak veneer laid over plywood (this was a major job which involved totally destroying the old cabin sole). Two engineers and two labourers then came and pulled the tanks out after much wrenching with crowbars. The tanks just fitted down Envoy's passageways with a few mm to spare, but the Demir guys were very considerate and taped bubble wrap over all the bulkheads so that no timber was damaged as the tanks were

ENVOY'S GUEST CABIN AFTER STRIPPING OUT BUILT-IN FURNITURE, SHOWING THE WATER TANKS BEFORE THEY WERE REMOVED.

carried out. Now we had an empty shell where the guest cabin had been, and a large pile of broken timbers. The carpenter was a real professional, and had a great sense of humour; I asked him if he would remember how everything went back together, and he replied laughing, "I hope so". We ascertained the old tanks were rusted beyond economical repair, and Demir estimated one week to make and install the two new tanks using 316 stainless steel, and then one week to re-build the guest cabin.

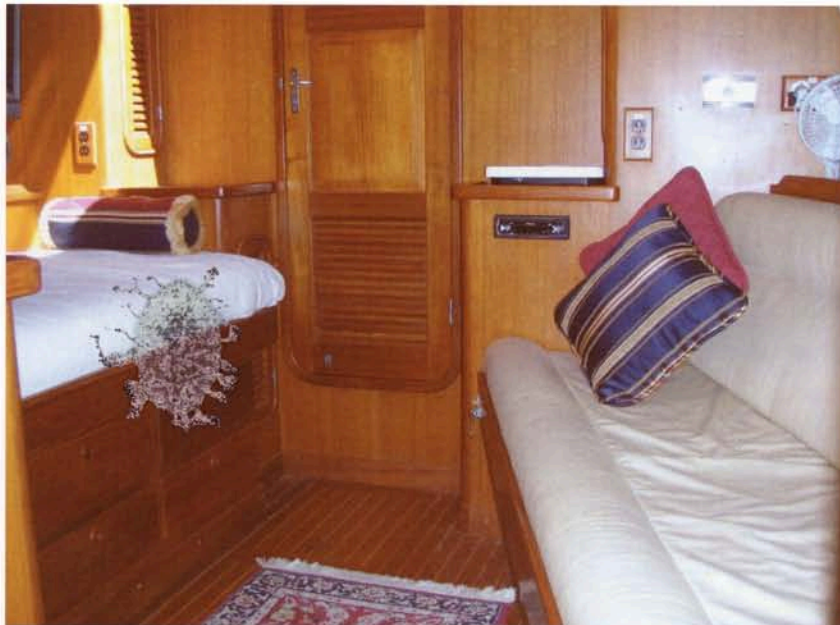
ENVOY'S FULLY RESTORED GUEST CABIN AFTER THE NEW TANKS HAD BEEN INSTALLED UNDER THE CABIN SOLE.

A few days later the new water tanks were completed and installed. The carpenter returned and fortunately did remember how everything went back together during the course of the week it took him to rebuild the cabin. He built the cabin sole in such a way that it can be removed if we have any future problems.
